ST PETER'S TOWER CLOCK

**PRIOR TO COMMENCING THE
REPAIR AND REFURBISHMENT
OF THE CLOCK THE TOWER WAS
IN NEED OF REPAIR. IT NEEDED
TO BE MADE WATERTIGHT AND
A SAFE ENVIRONMENT FOR THE
CLOCK COMPANY TO WORK IN.**

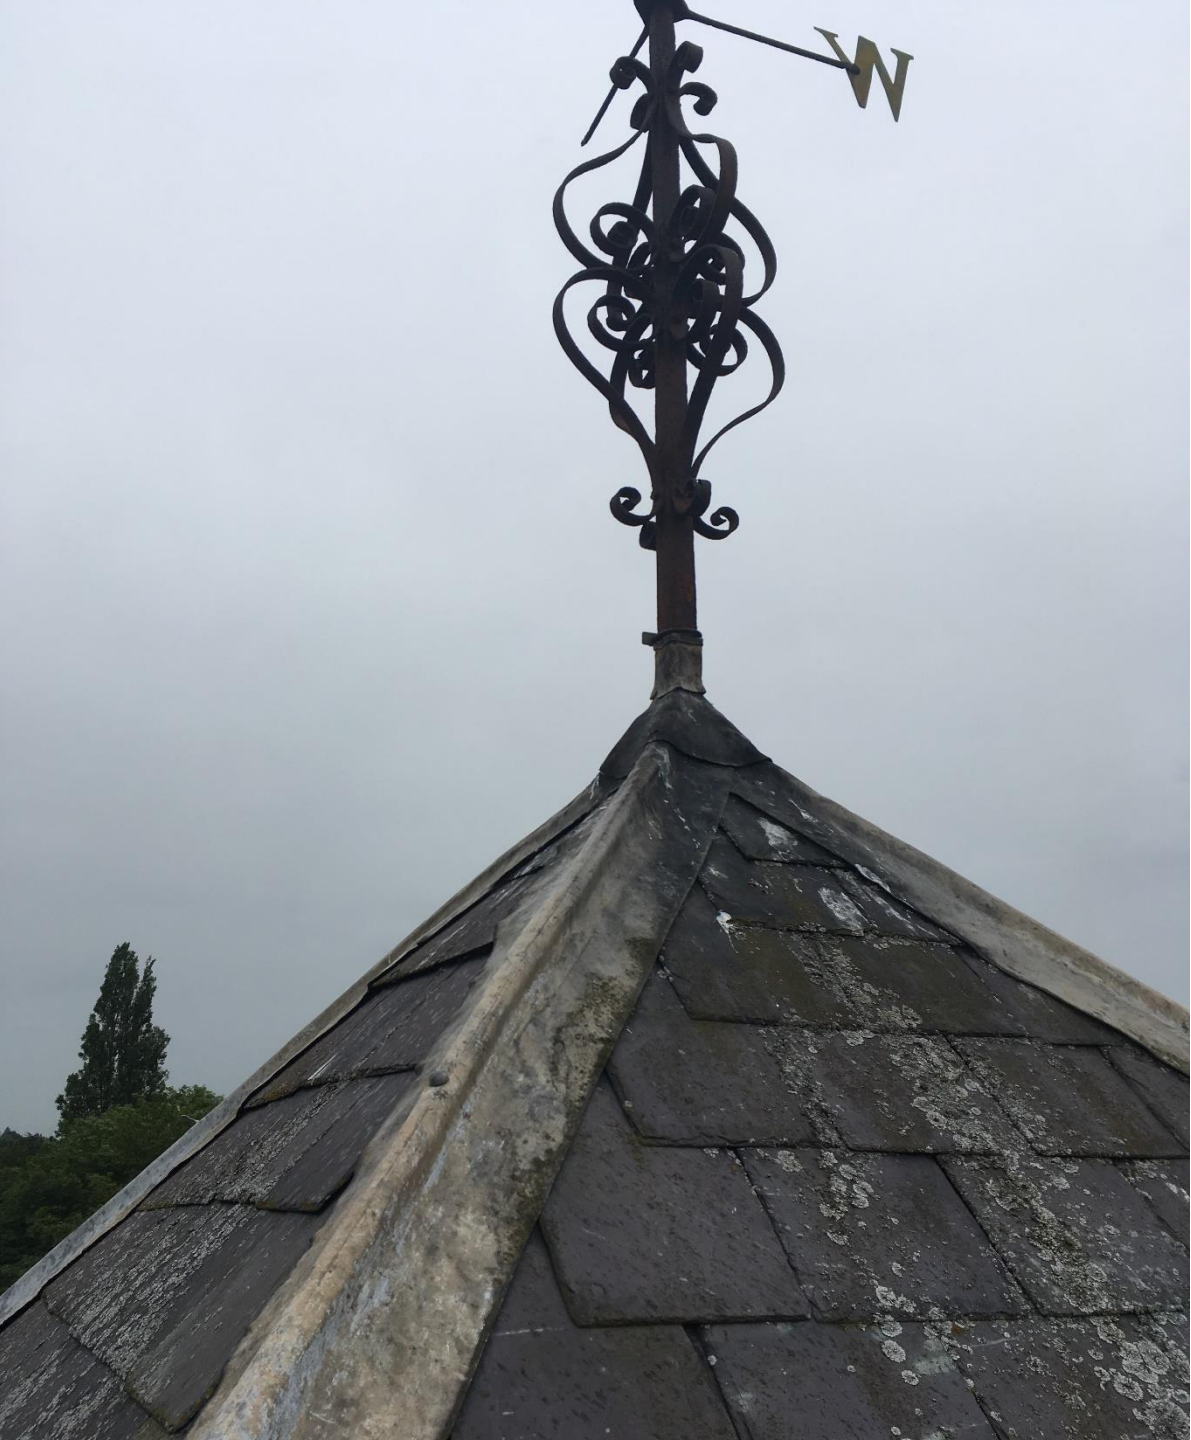
New tiles
on the
tower roof

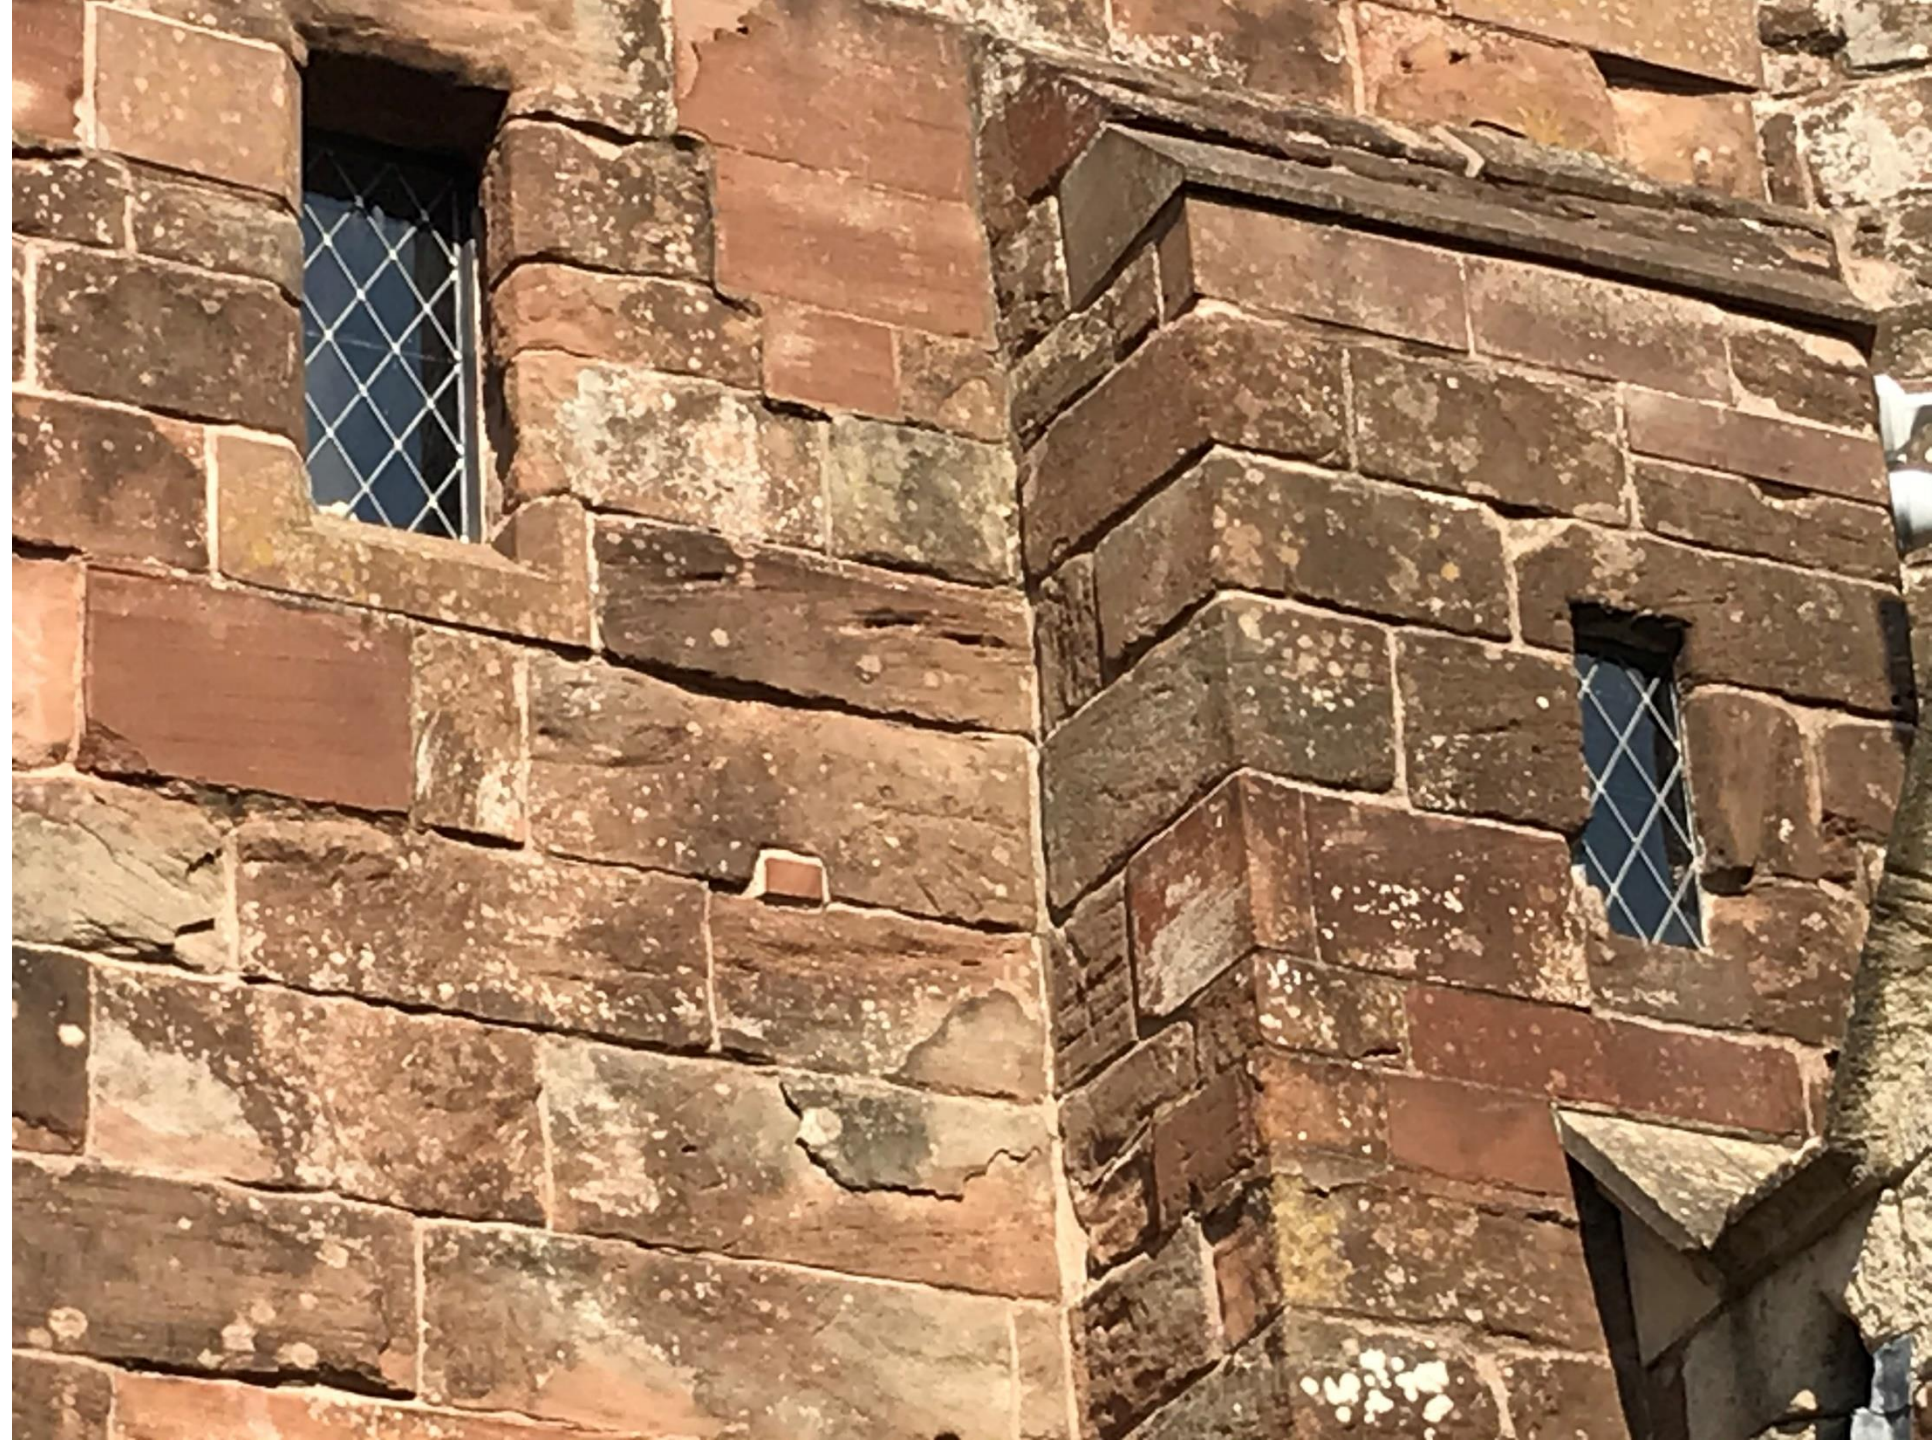
**NEW
WINDOWS
IN THE
TOWER**
